## Crash test of the Typhoon II wheelchair and Typhoon docking station according to ISO 10542

A crash test of the Typhoon docking station for the Typhoon II electrical wheelchair has been performed according to ISO 10542-3:2005, section 6.1.

By commission of Invacare Deutschland GmbH a crash test of the Typhoon docking station for the Typhoon II electrical wheelchair was performed according to ISO 10542-3:2005, section 6.1. The purpose of the test was to evaluate if the Typhoon docking station fulfilled the crash test requirements together with the new Typhoon II wheelchair.

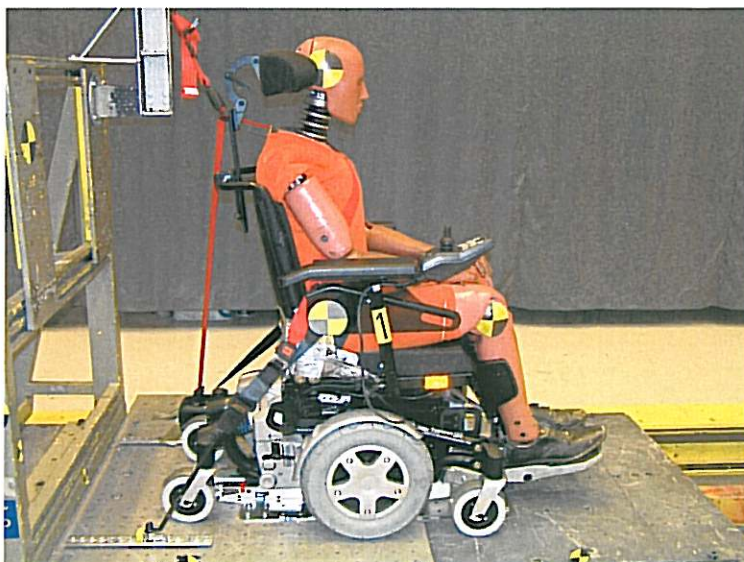
**Figure 1** Test setup

The test object was mounted directly on the sled in a forward direction and the wheelchair was attached to the docking station. A Hybrid III-dummy, 76 kg, was positioned in the test wheelchair and restrained by an Unwin belt.

The sled was accelerated to a speed of 50.6 km/h before impact.
