REPORT

Crash testing of wheelchair XLT 75° according to ISO 7176-19:2001

A crash test of the XLT 75° wheelchair has been performed according to ISO 7176-19:2001, chapter 5.2. The wheelchair was crash tested with a Hybrid III-dummy, 76 kg, in 48-50 km/h.

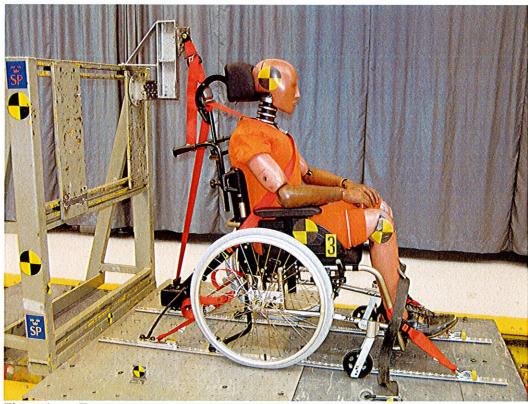
Figure 1 Test setup

The test object was mounted in a forward direction and attached to the sled with a 4-point tiedown system from Unwin. A Hybrid III-dummy, 76 kg, was positioned in the test object. The sled was accelerated to a speed of 49.5 km/h before impact.

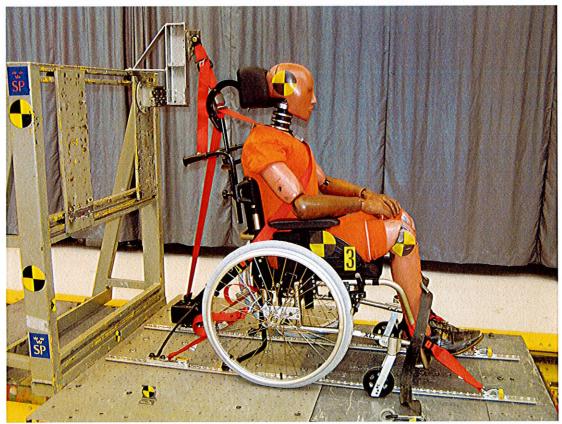
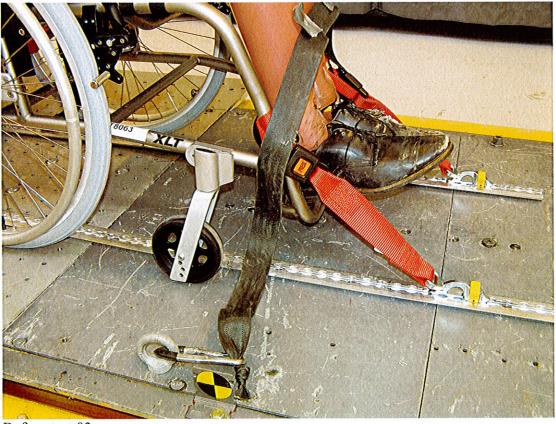
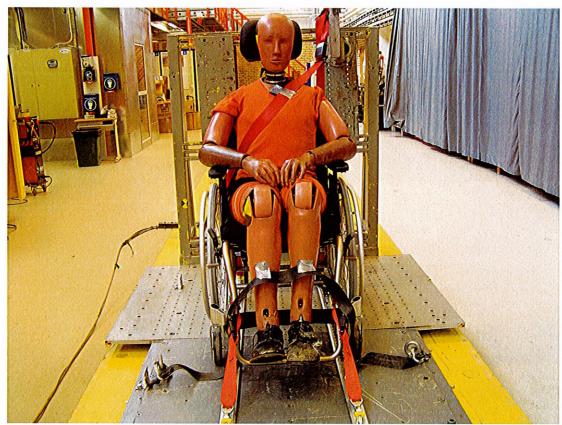
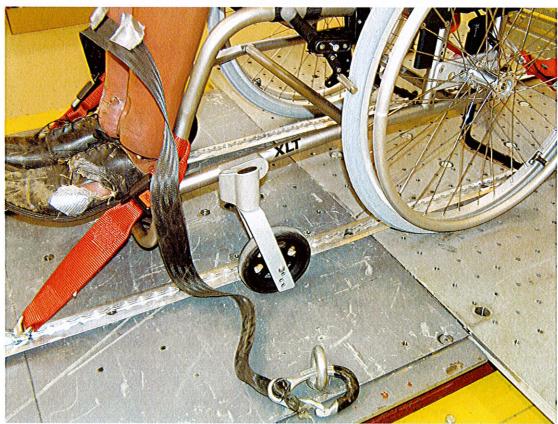
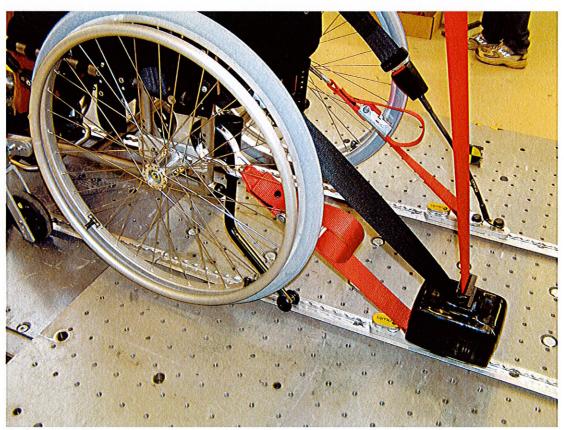
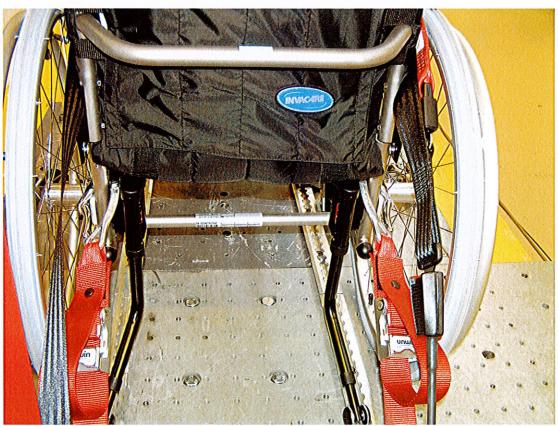
Before test 03

Photos were taken before and after the test and can be found in appendix 2.

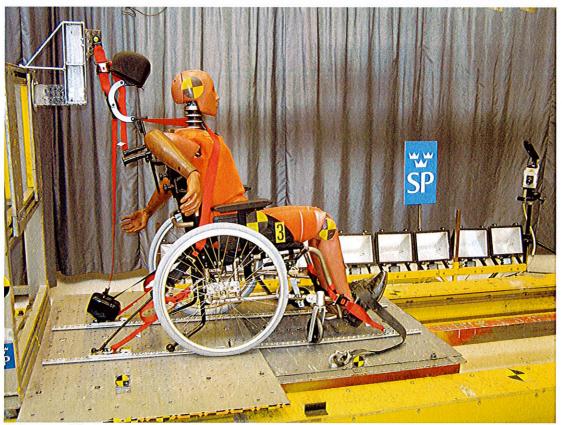
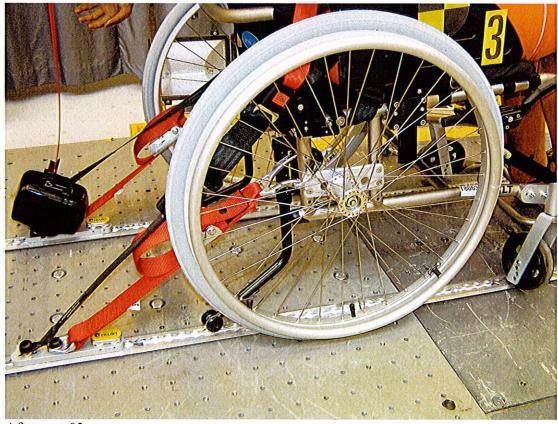
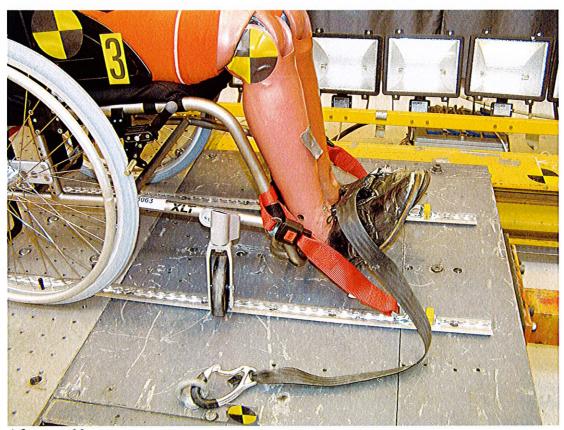
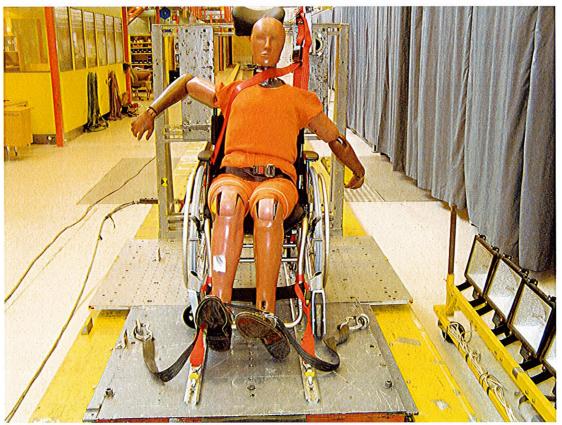
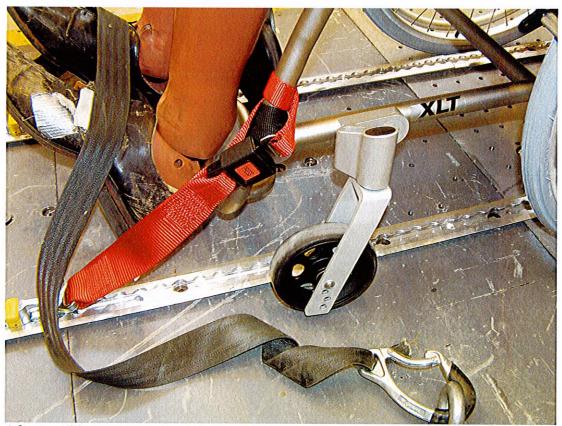
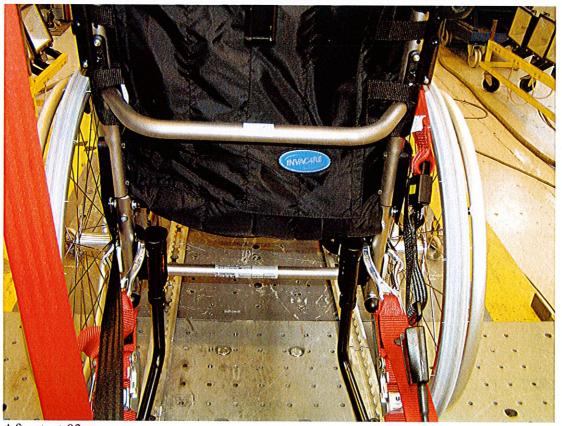
After test 03
